Technical Support Center: Antimony Phosphide in Electronic Devices

Author: BenchChem Technical Support Team. **Date:** December 2025

Compound Name: Antimony phosphide

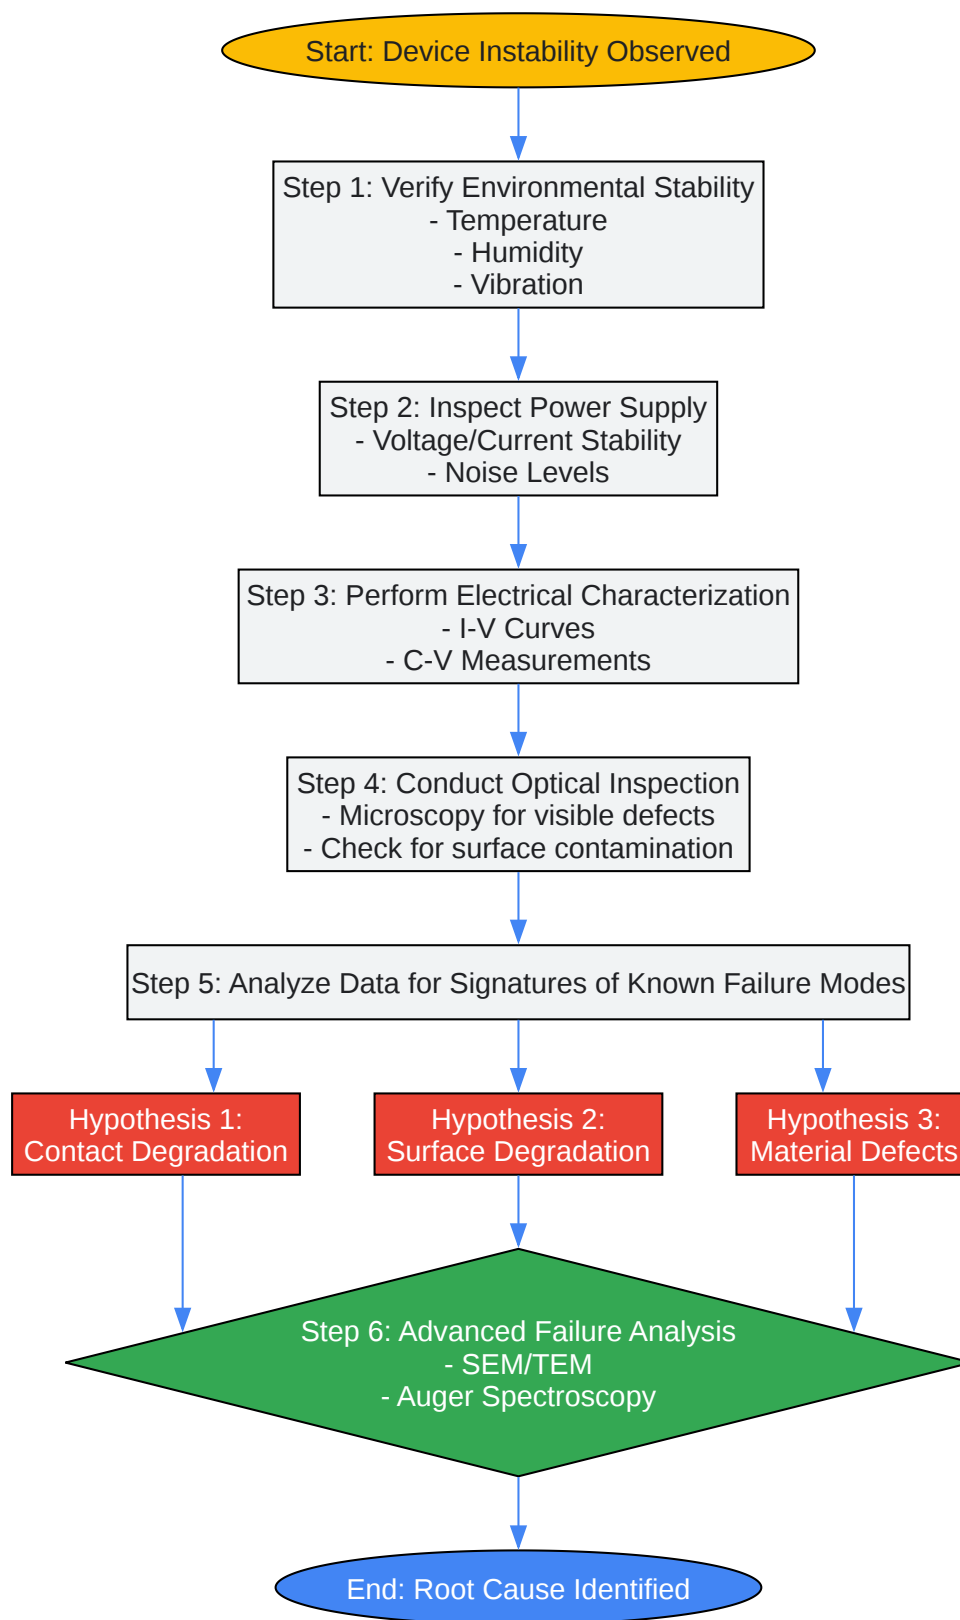
Troubleshooting Workflow:

Caption: Troubleshooting workflow for device instability.

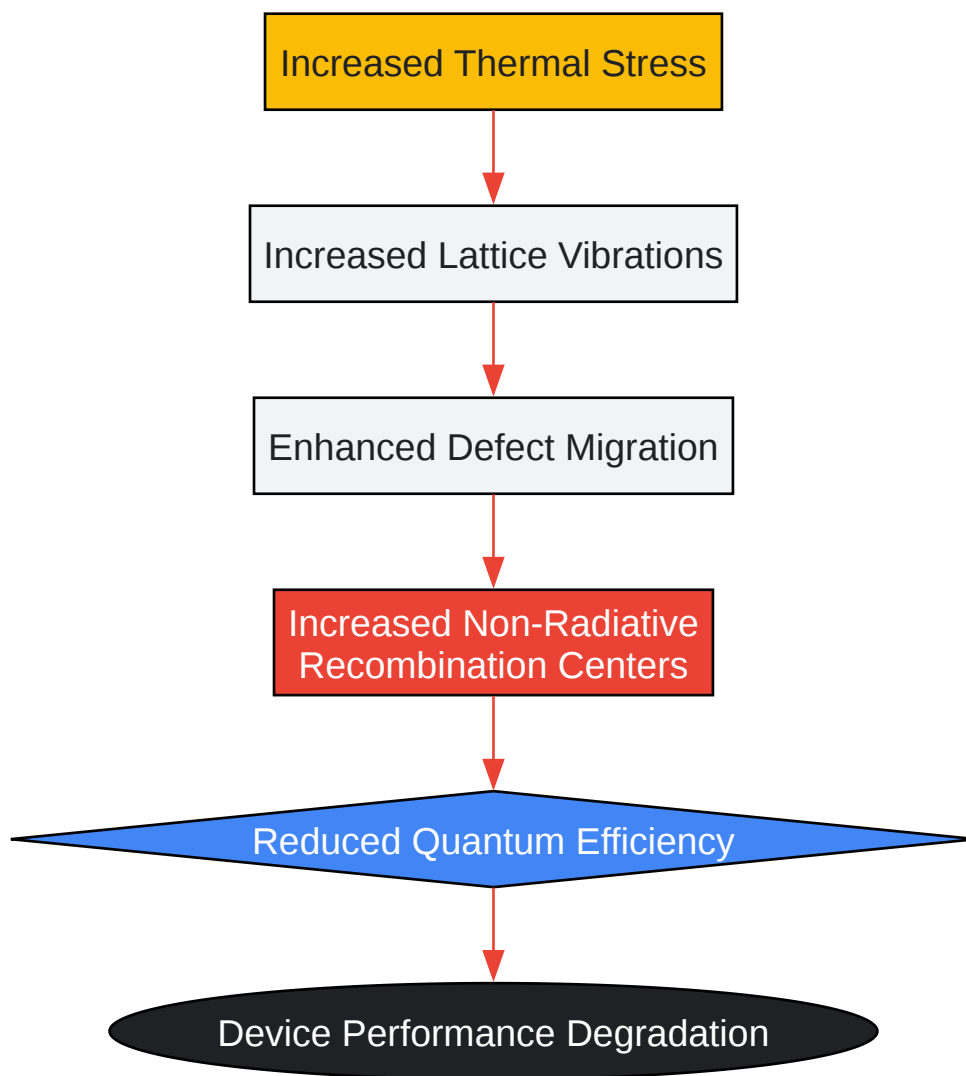
Hypothetical Degradation Pathway

The following diagram illustrates a hypothetical signaling pathway for the degradation of an SbP device due to thermal stress leading to increased defect migration.
