HPE 5945 configuration errors and solutions

HPE 5945 Technical Support Center

Welcome to the technical support center for the HPE 5945 switch series. This resource is designed for researchers, scientists, and drug development professionals who may encounter network configuration challenges during their experiments. Below you will find troubleshooting guides and Frequently Asked Questions (FAQs) to help you resolve common issues.

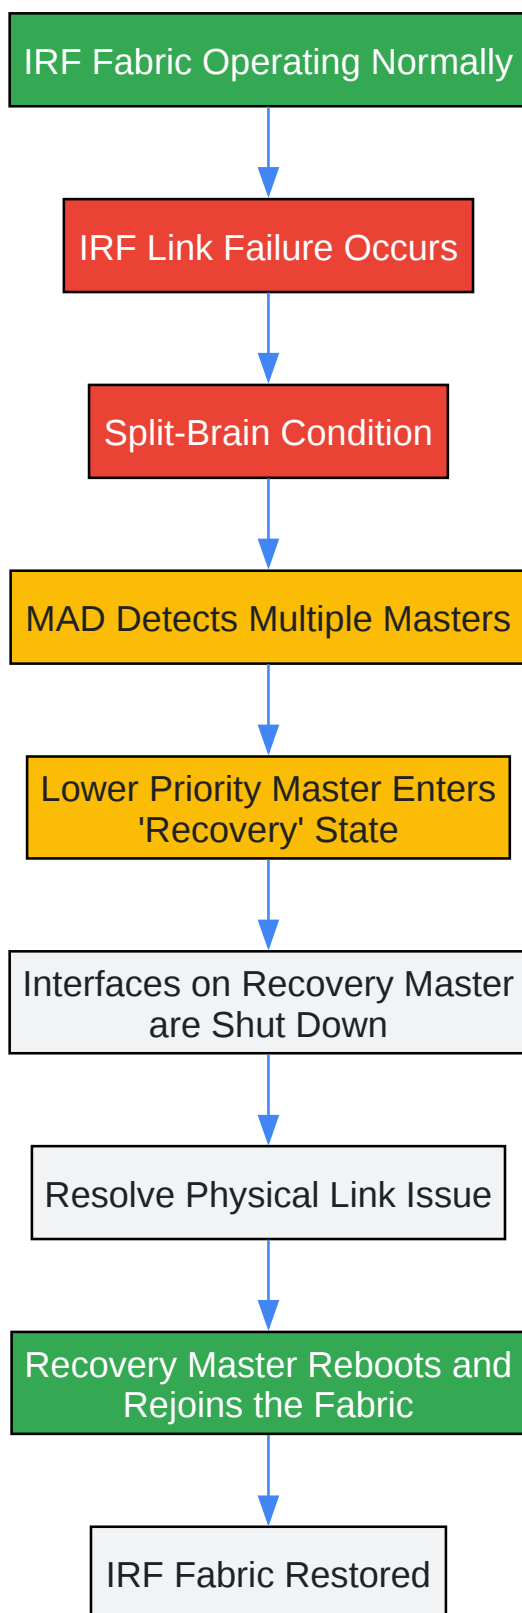
Logical Flow for IRF Split-Brain Detection and Recovery

Caption: IRF Split-Brain Detection and Recovery Workflow.

An IRF split-brain occurs when the links between IRF members fail, causing the single logical fabric to split into two or more independent fabrics that are still active and using the same IP address. This can lead to network instability and connectivity issues.[\[2\]](#)

- **Identify the Cause:** Investigate the reason for the IRF link failure. This could be a faulty cable, a malfunctioning transceiver, or a misconfiguration.
- **Resolve the Link Failure:** Replace any faulty hardware or correct the configuration that caused the link to go down.
- **Merge the Fabrics:** Once the physical link is restored, the IRF fabric in the "Recovery" state will typically reboot and rejoin the active fabric automatically.
- **Manual Recovery:** If the active fabric fails before the link is restored, you can use the `mad restore` command on the inactive fabric to bring its interfaces back up and restore services.

This can be expected behavior if you are using BFD for Multi-Active Detection (MAD) and have `irf mac-address persistent` always configured. In a split-brain scenario, both masters may attempt to use the same MAC address, leading to flapping on upstream devices. To mitigate this, you can consider using the `undo irf mac-address persistent` command.

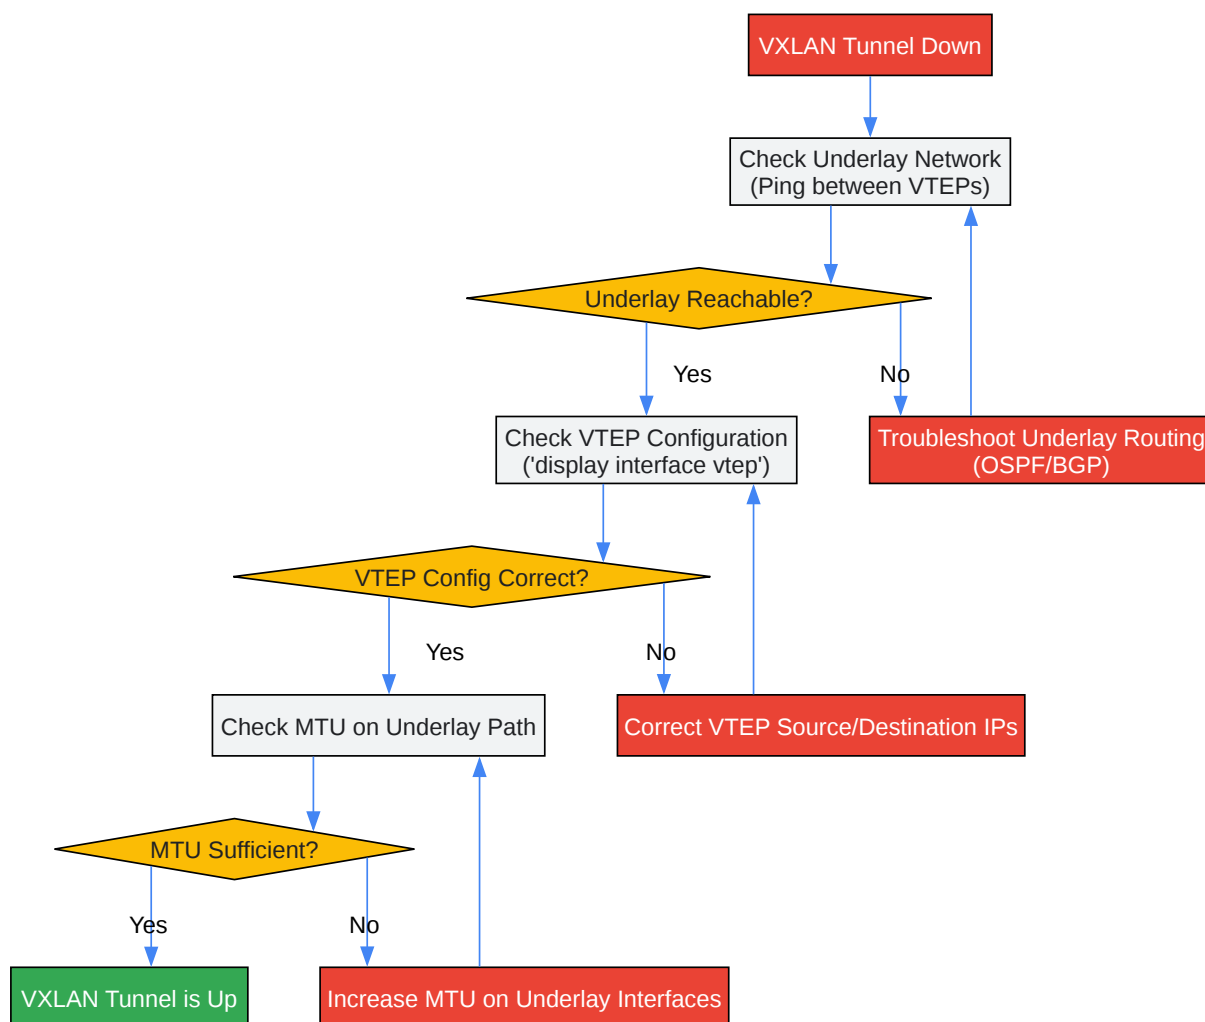
Troubleshooting Flow for VXLAN Tunnel Issues

Caption: A logical workflow for troubleshooting VXLAN tunnel connectivity.

- **Verify Underlay Reachability:** The VTEPs (VXLAN Tunnel Endpoints) must be able to reach each other over the underlay network. Use the ping command with the source VTEP IP address to test connectivity to the destination VTEP IP address.

- **Check VTEP Configuration:**
 - Use the `display interface vtep` command to check the status of the VTEP interfaces.
 - Ensure that the source and destination IP addresses are correctly configured.

- **Inspect the Underlay Routing:** The routing protocol in the underlay network (e.g., OSPF or BGP) must be advertising the routes to the VTEP loopback interfaces.

- **MTU Mismatch:** VXLAN adds overhead to packets. Ensure that the MTU of all interfaces in the underlay network is large enough to accommodate the encapsulated packets.

- **Enable Overlay OAM:** For advanced troubleshooting, enable Overlay OAM (Operations, Administration, and Maintenance) to use tools like `ping vxlan` and `tracert vxlan` to test the VXLAN tunnel itself.

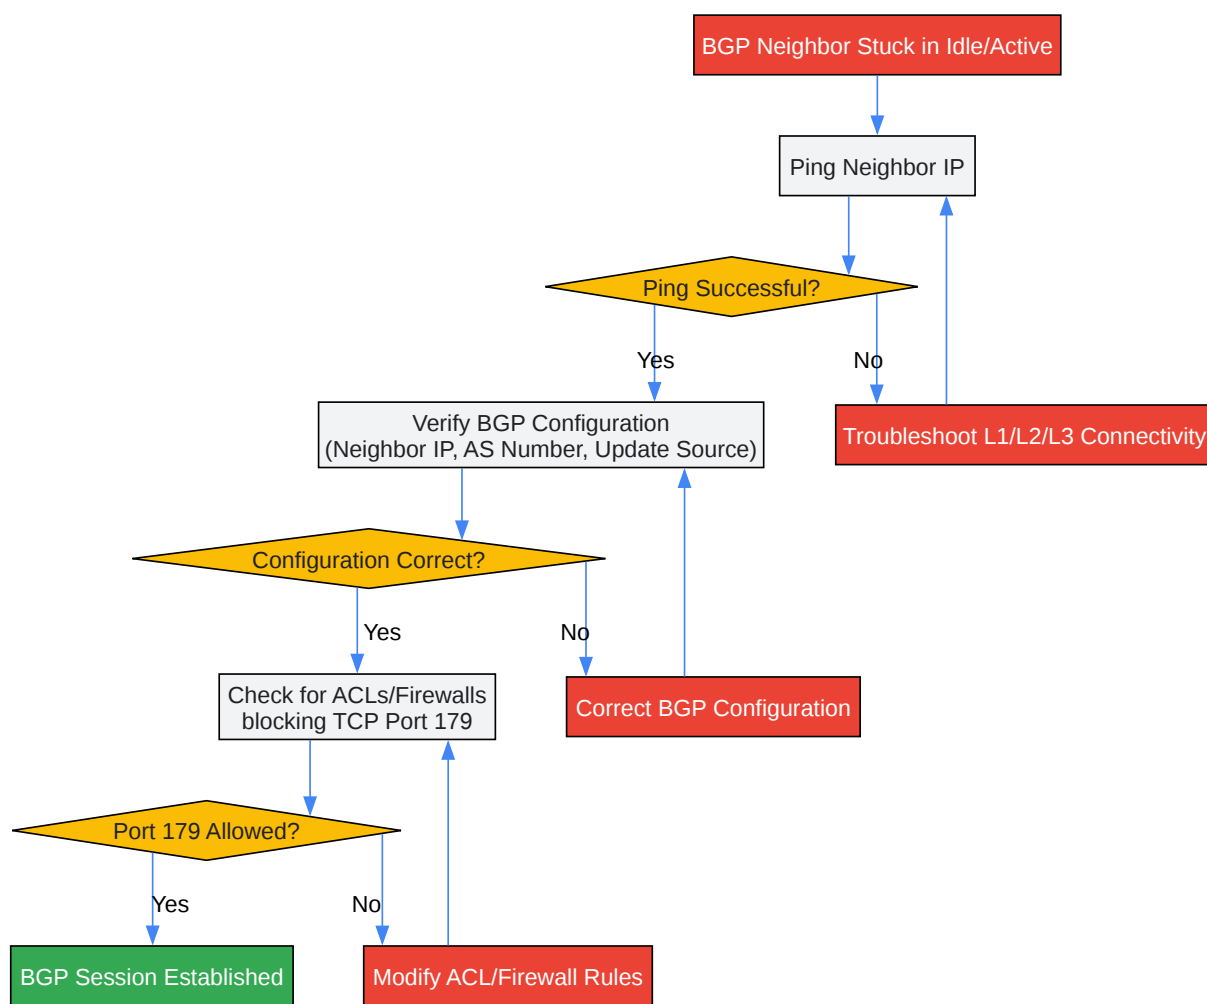
BGP Neighbor State Troubleshooting Flow

Caption: A step-by-step guide to troubleshooting BGP neighbor states.

A BGP session stuck in "Idle" or "Active" state indicates a problem with establishing the TCP session between the peers.

- **Verify IP Connectivity:** Use the ping command to ensure there is basic IP reachability between the BGP neighbors. If you are using loopback interfaces for peering, make sure to source the ping from the loopback interface.
- **Check BGP Configuration:**
 - **Neighbor IP Address and AS Number:** Double-check that the peer as-number command is correctly configured on both routers.
 - **Update Source:** If using loopback interfaces, ensure the peer connect-interface LoopBack command is configured.
- **Check for Firewalls or ACLs:** Ensure that no firewalls or access control lists are blocking TCP port 179 between the BGP neighbors.
- **eBGP Multihop:** If the eBGP peers are not directly connected, you must configure peer ebgp-max-hop.
