# Propachlor Gas Chromatography: A Technical Support Troubleshooting Guide

**Author:** BenchChem Technical Support Team. **Date:** December 2025

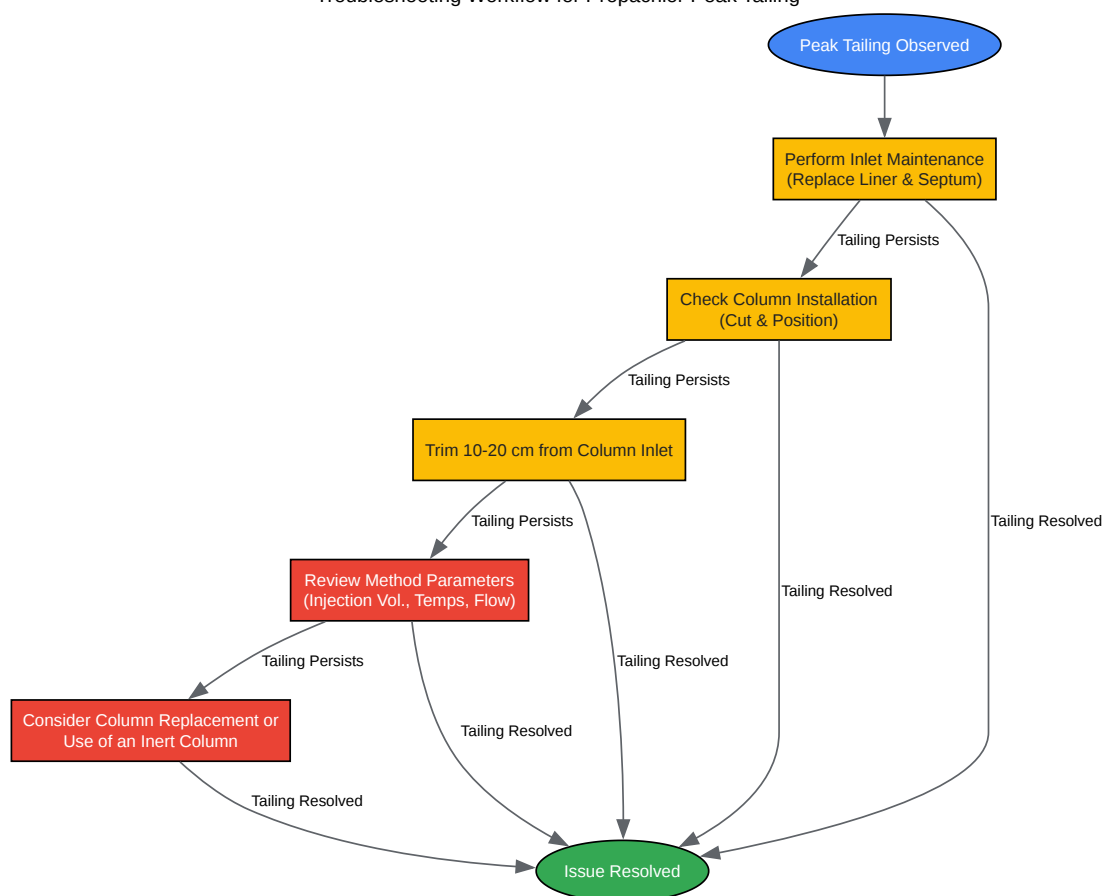
## Troubleshooting Workflow for Propachlor Peak Tailing

Caption: A flowchart for troubleshooting peak tailing in **propachlor** GC analysis.

A3: A structured approach is the most efficient way to identify and resolve the source of peak tailing.[9] Begin with the simplest and most common potential causes before moving to more complex issues. A recommended workflow is to first perform routine maintenance on the inlet, such as replacing the liner and septum, as this is a frequent source of problems.[1][7] If the issue persists, trimming a small section off the front of the column can remove contaminants.[2][9] If these steps do not resolve the tailing, a more thorough investigation of the GC method parameters and the overall health of the column is necessary.
