# Technical Support Center: Potassium Dicyanoaurate Plating Baths

This technical support center provides troubleshooting guidance and frequently asked questions (FAQs) to address stability issues encountered by researchers, scientists, and drug development professionals working with **potassium dicyanoaurate** plating baths.

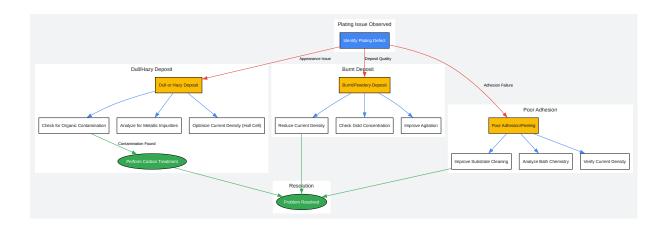
Caption: Troubleshooting workflow for common gold plating defects.

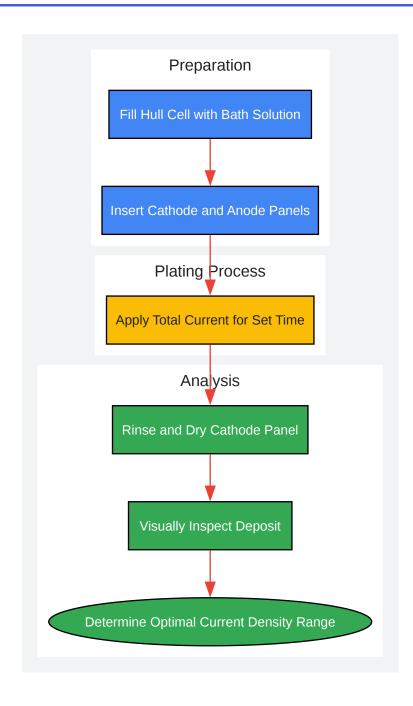
Caption: Experimental workflow for Hull cell analysis.

- After plating, rinse and dry the panel.
  - Visually inspect the panel to identify the current density range that produces the desired deposit appearance (bright, uniform, and free of defects). The current density at any point on the panel can be calculated using a Hull cell ruler.
