# Technical Support Center: Troubleshooting Cefacetrile Sodium HPLC Peak Tailing

**Author:** BenchChem Technical Support Team. **Date:** December 2025

This technical support guide provides researchers, scientists, and drug development professionals with a comprehensive resource for troubleshooting peak tailing issues encountered during the High-Performance Liquid Chromatography (HPLC) analysis of **Cefacetrile sodium**. The following question-and-answer format directly addresses common problems and offers detailed, actionable solutions.

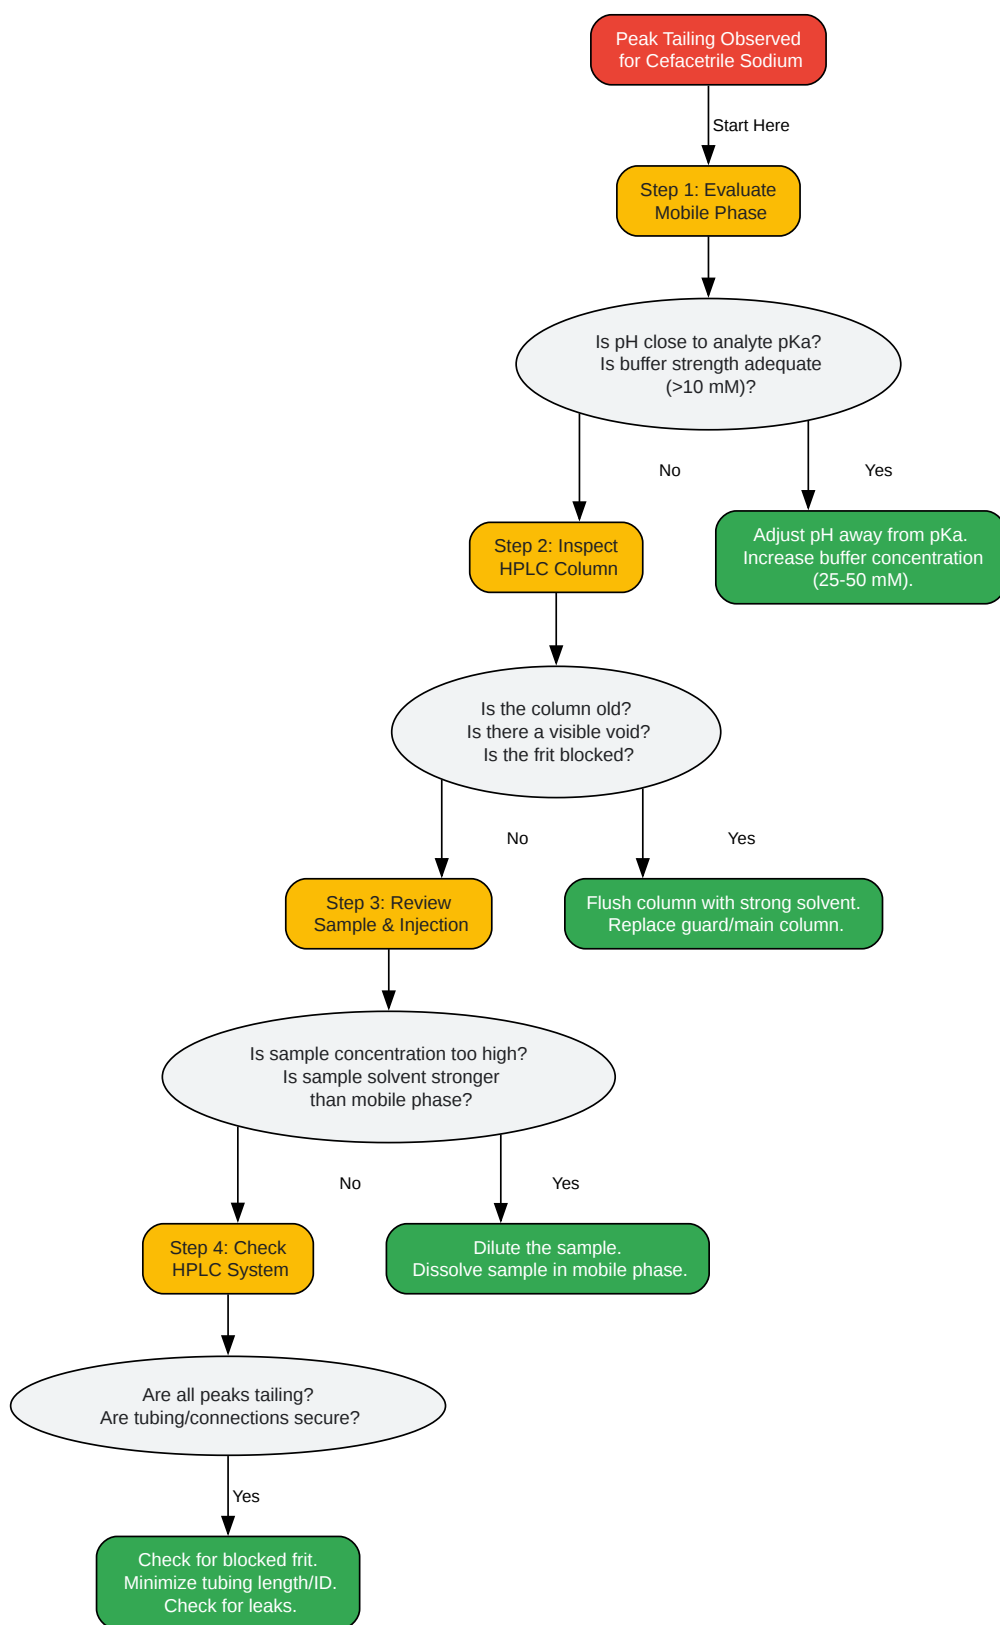
The diagram below outlines a logical workflow to diagnose the root cause of peak tailing.

Caption: A logical workflow for troubleshooting **Cefacetrile sodium** HPLC peak tailing.

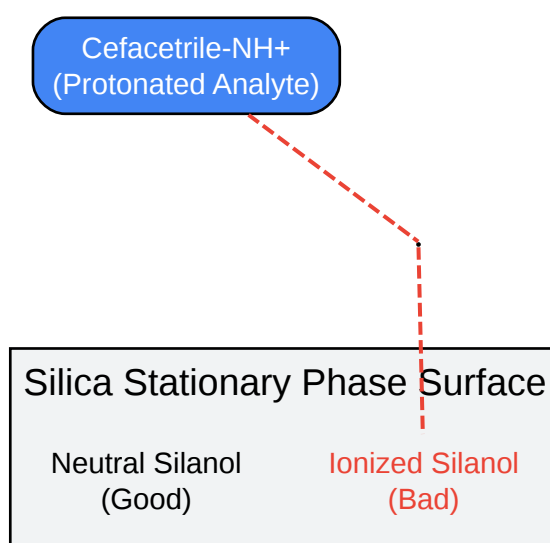
A3: Silanol groups (Si-OH) on the surface of silica-based columns are a primary cause of tailing for compounds with basic functional groups.[3] At a mid-range pH, these groups can deprotonate to the anionic form (Si-O<sup>-</sup>), which then strongly interacts with protonated basic analytes, causing a secondary retention mechanism that leads to tailing.[2][4]

The diagram below illustrates this unwanted interaction.

Caption: Secondary ionic interaction between an analyte and an ionized silanol group.
