Technical Support Center: Troubleshooting Inconsistent Extrusion of Texin® 192A

Compound Name: Texin 192A

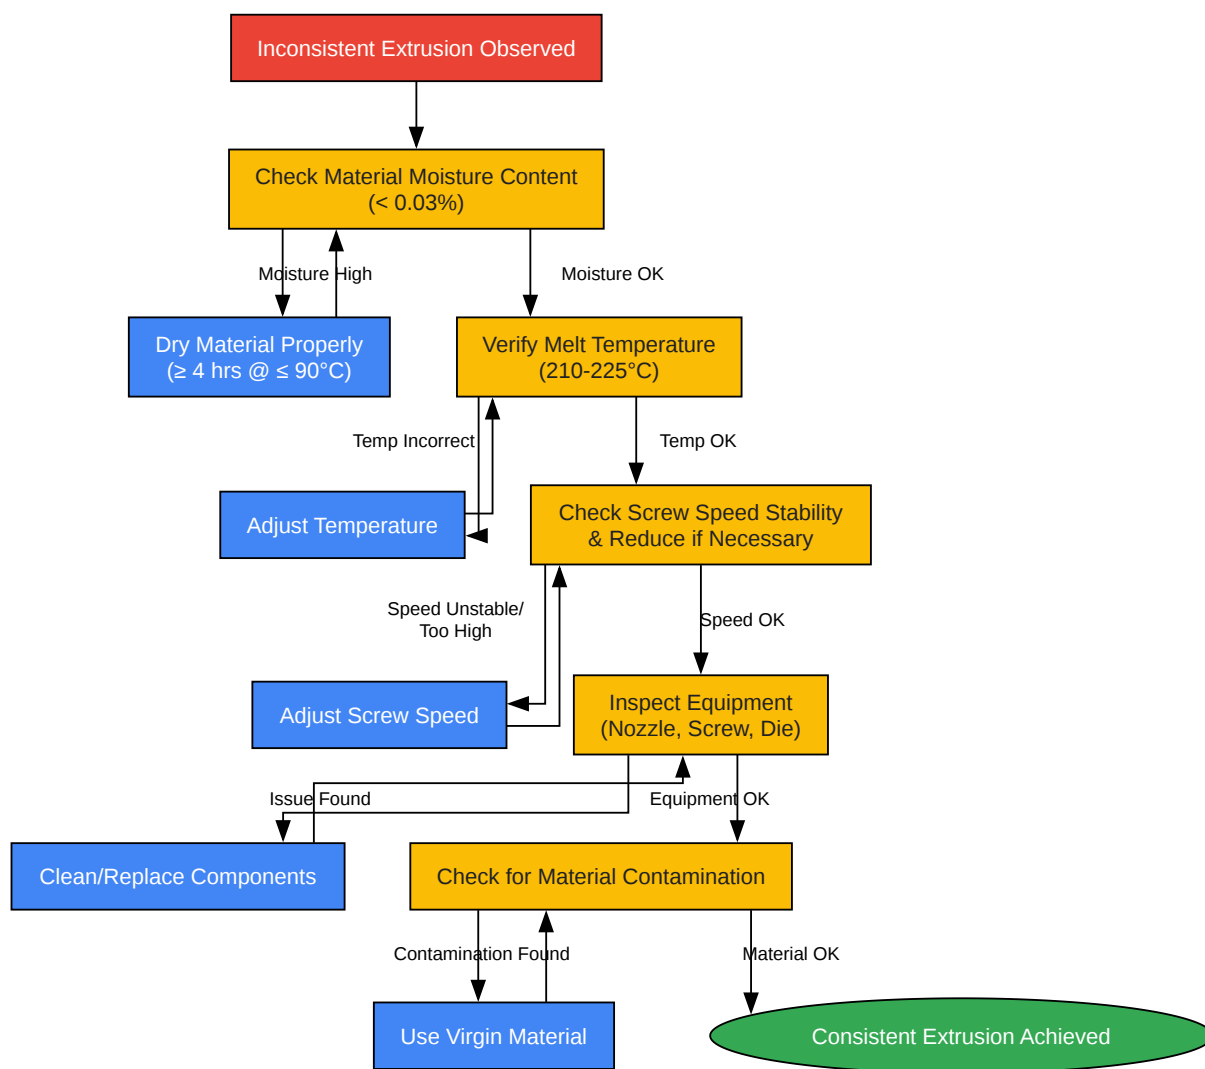
The following diagram illustrates a logical workflow for troubleshooting inconsistent extrusion of Texin® 192A.

A logical workflow for troubleshooting inconsistent extrusion.
