Technical Support Center: Troubleshooting PVAP Coating Defects

This technical support center provides guidance for researchers, scientists, and drug development professionals on troubleshooting common defects encountered during the **Polyvinyl Acetate Phthalate** (PVAP) coating process, specifically addressing "orange peel" and "twinning."

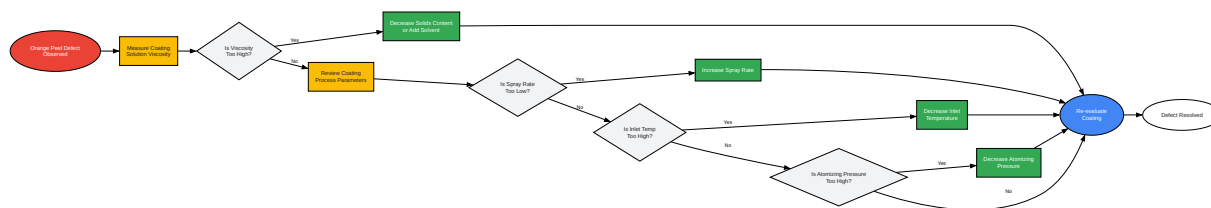
Troubleshooting Workflow for Orange Peel

Caption: Troubleshooting workflow for the orange peel defect.

Orange peel is typically caused by inadequate spreading of the coating solution on the tablet surface before it dries.^[3] The primary contributing factors can be categorized into formulation-related and process-related issues.

Parameter	Potential Cause of Orange Peel	Recommended Solution
Coating Solution Viscosity	Too high, preventing proper atomization and spreading.[2]	Decrease the solids content of the coating solution or add more solvent to reduce viscosity.
Spray Rate	Too low, causing premature drying of droplets before they reach the tablet surface.[3]	Increase the spray rate to ensure droplets are sufficiently wet upon impact.
Atomizing Air Pressure	Too high, leading to rapid drying of the spray.[2]	Reduce the atomizing air pressure to prevent premature drying of the coating droplets.
Inlet Air Temperature	Too high, causing the spray to dry before adequately spreading on the tablet surface.[4]	Lower the inlet air temperature to allow for better film formation.
Pan Speed	Too low, leading to overwetting and uneven coating distribution.[2]	Increase the pan speed to ensure tablets tumble effectively and are evenly exposed to the spray.

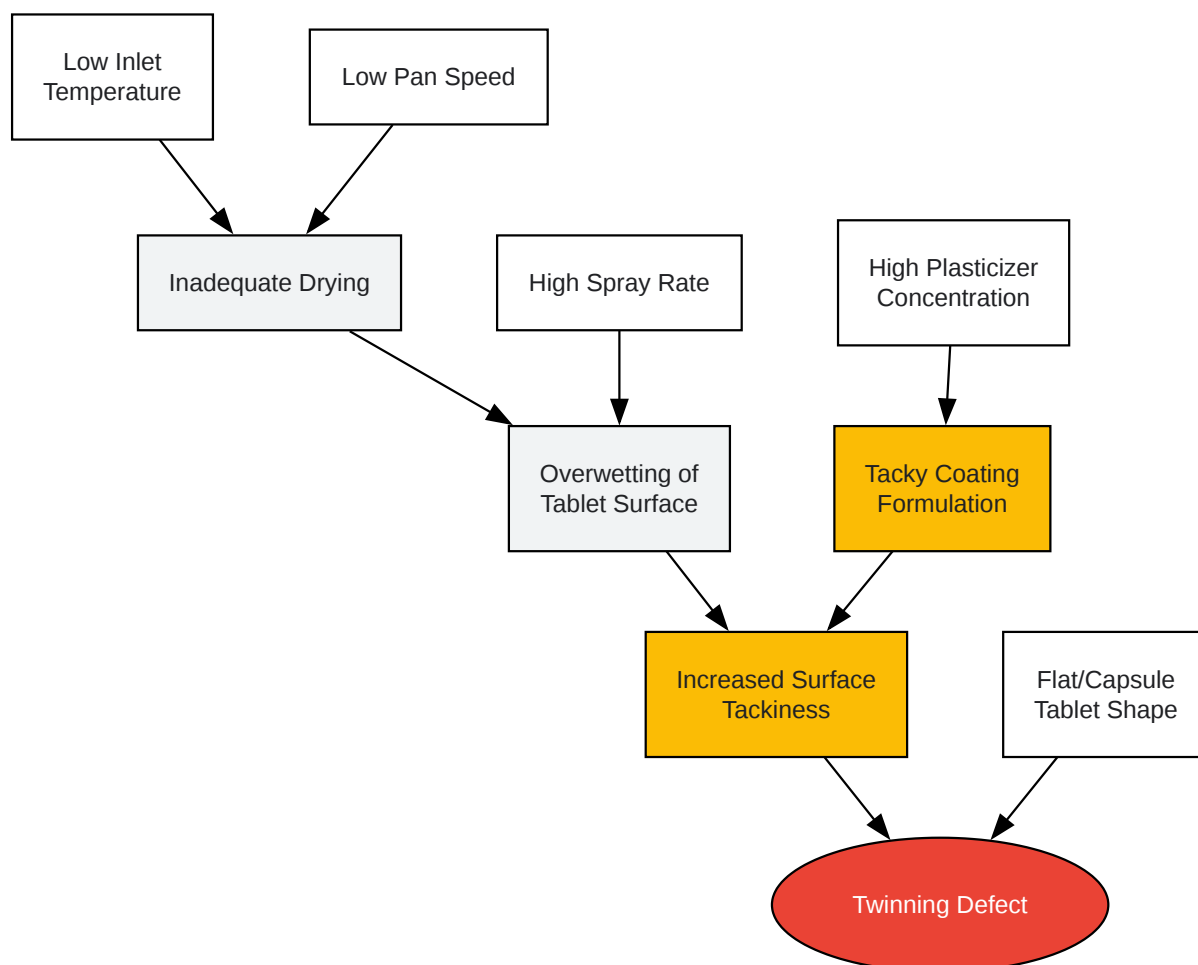
Logical Relationships in Twinning Defect Formation

Caption: Factors contributing to the twinning defect in tablet coating.

Twinning is primarily caused by excessive tackiness of the tablet surface during the coating process.^[5] This can be influenced by the coating formulation, process parameters, and the shape of the tablets themselves.

Parameter	Potential Cause of Twinning	Recommended Solution
Coating Formulation Tackiness	High concentration of plasticizer or use of a tacky polymer.	Optimize the type and concentration of the plasticizer. Consider adding an anti-tacking agent like talc.
Spray Rate	Too high, leading to overwetting of the tablet surfaces.[4][5]	Reduce the spray rate to allow for adequate drying between spray cycles.
Inlet Air Temperature	Too low, resulting in insufficient drying and tacky surfaces.	Increase the inlet air temperature to enhance drying efficiency.
Pan Speed	Too low, increasing the contact time between tablets.[6]	Increase the pan speed to promote better tumbling and reduce tablet-to-tablet contact time.[6]
Tablet Shape	Flat or capsule-shaped tablets have a larger contact area, making them more prone to sticking.[7]	If possible, consider a more rounded or convex tablet shape in the design phase.[7]
