Technical Support Center: Troubleshooting Peak Tailing in Chlorinated Biphenyl Analysis

Author: BenchChem Technical Support Team. **Date:** December 2025

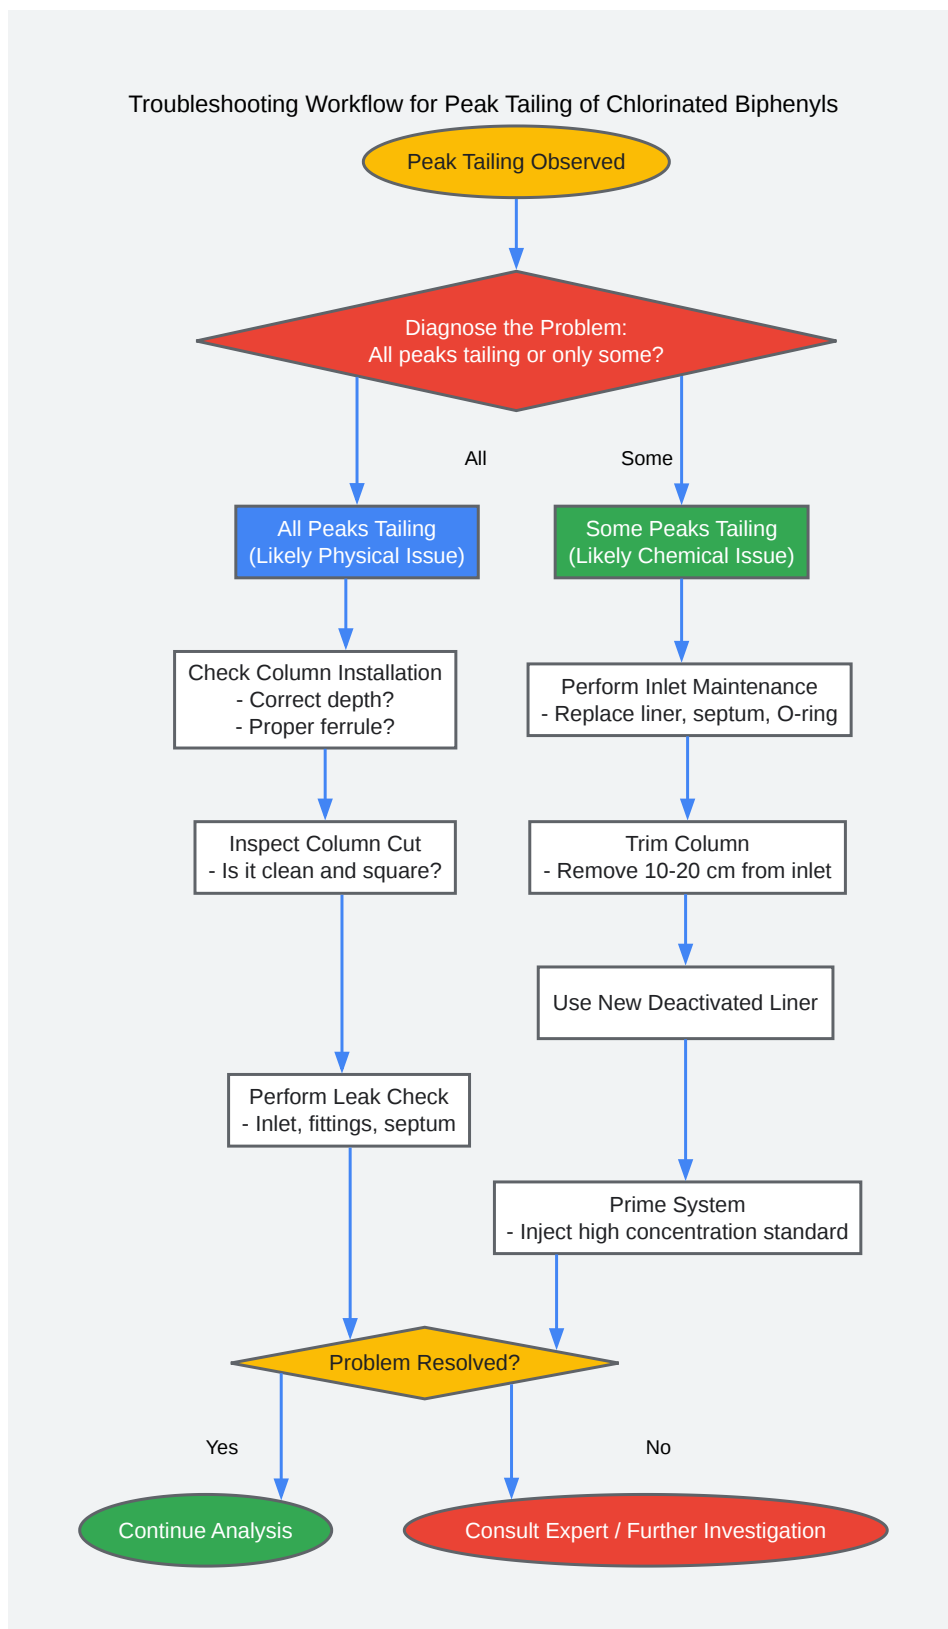
Troubleshooting Workflow

Caption: Troubleshooting workflow for peak tailing.

- If all peaks, including the solvent peak, are tailing: This typically indicates a physical or mechanical issue in the GC system, such as a disruption in the carrier gas flow path.^{[4][5]}
- If only some peaks, particularly the more polar or active PCBs, are tailing: This is more suggestive of a chemical interaction or adsorption problem within the system.^{[5][6]}
