Technical Support Center: Troubleshooting Peak Tailing in GC Analysis of Terpenoids

Author: BenchChem Technical Support Team. **Date:** December 2025

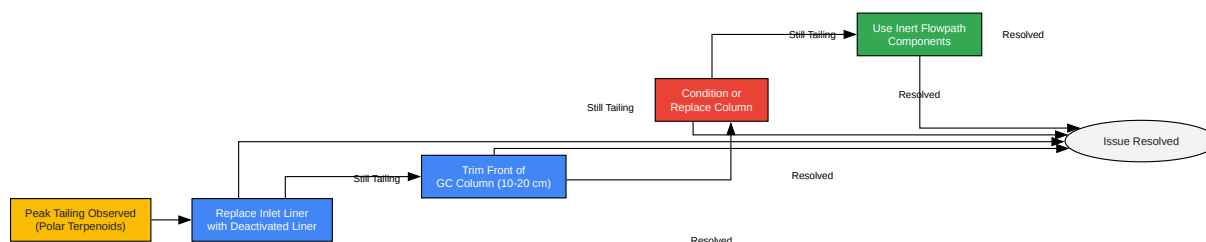
Logical Troubleshooting Flow for Chemical Issues

Caption: Troubleshooting workflow for chemical causes of peak tailing.

- Action: Replace the inlet liner with a new, deactivated liner. Consider using liners with advanced deactivations designed for active compounds.[\[8\]](#)

- Column Conditioning and Maintenance: The front end of the GC column can become contaminated or active over time.[\[2\]](#)[\[6\]](#)
 - Action: Trim the first 10-20 cm from the inlet end of the column to remove any accumulated non-volatile residues or active sites.[\[8\]](#)[\[10\]](#)

- Use of Inert Components: Ensure all components in the sample flow path are as inert as possible.
 - Action: Utilize deactivated injection port liners and gold-plated seals to minimize interactions.[\[11\]](#)
