Technical Support Center: Troubleshooting Plasma Instability in Co-Tb Co-Sputtering

Author: BenchChem Technical Support Team. **Date:** November 2025

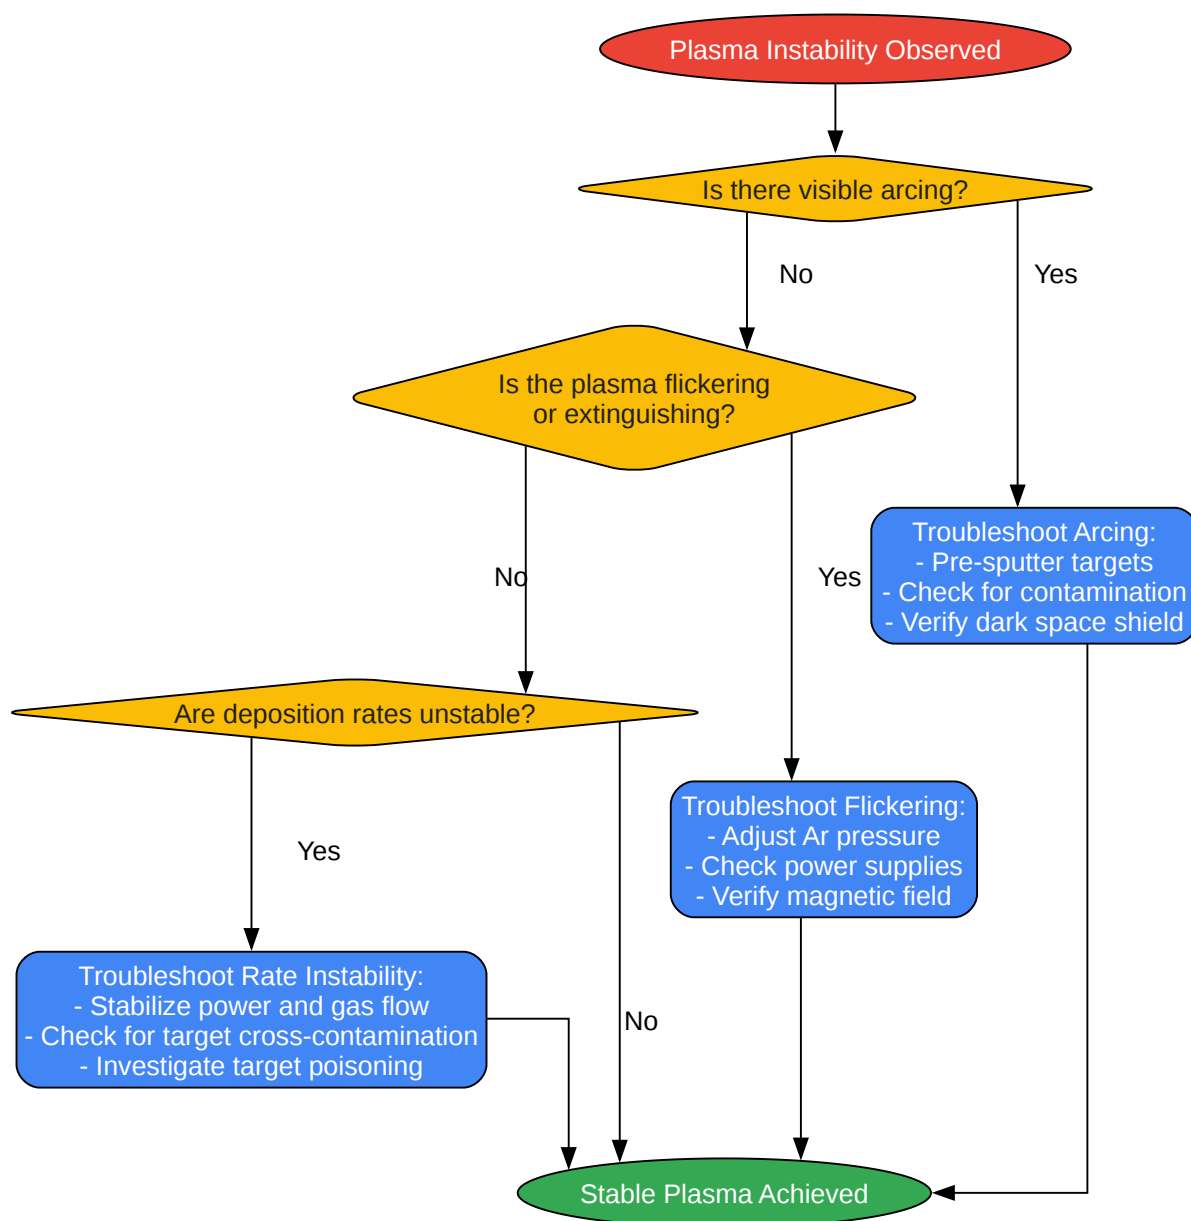
The following diagram illustrates a logical workflow for troubleshooting common plasma instability issues during Co-Tb co-sputtering.

Troubleshooting workflow for plasma instability.

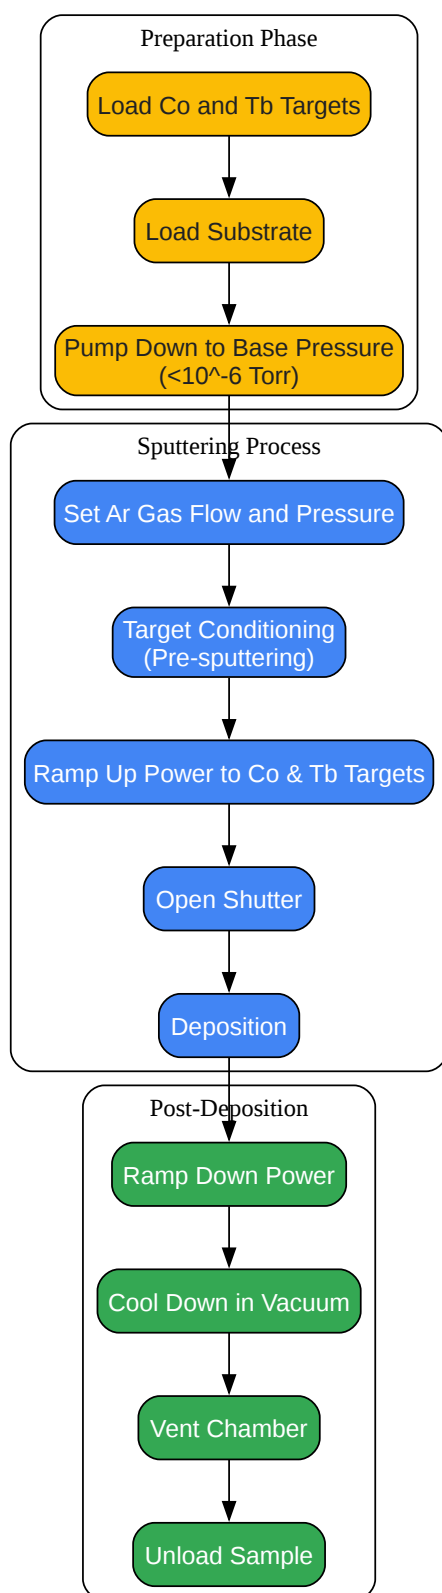
This diagram outlines the key steps in a typical Co-Tb co-sputtering experiment, from preparation to deposition.

Experimental workflow for Co-Tb co-sputtering.
