Technical Support Center: Troubleshooting Quenching Effects in Sodium Iodide Scintillators

This technical support center provides troubleshooting guides and frequently asked questions (FAQs) to help researchers, scientists, and drug development professionals identify and resolve common issues related to quenching effects in **sodium iodide** (NaI(Tl)) scintillators.

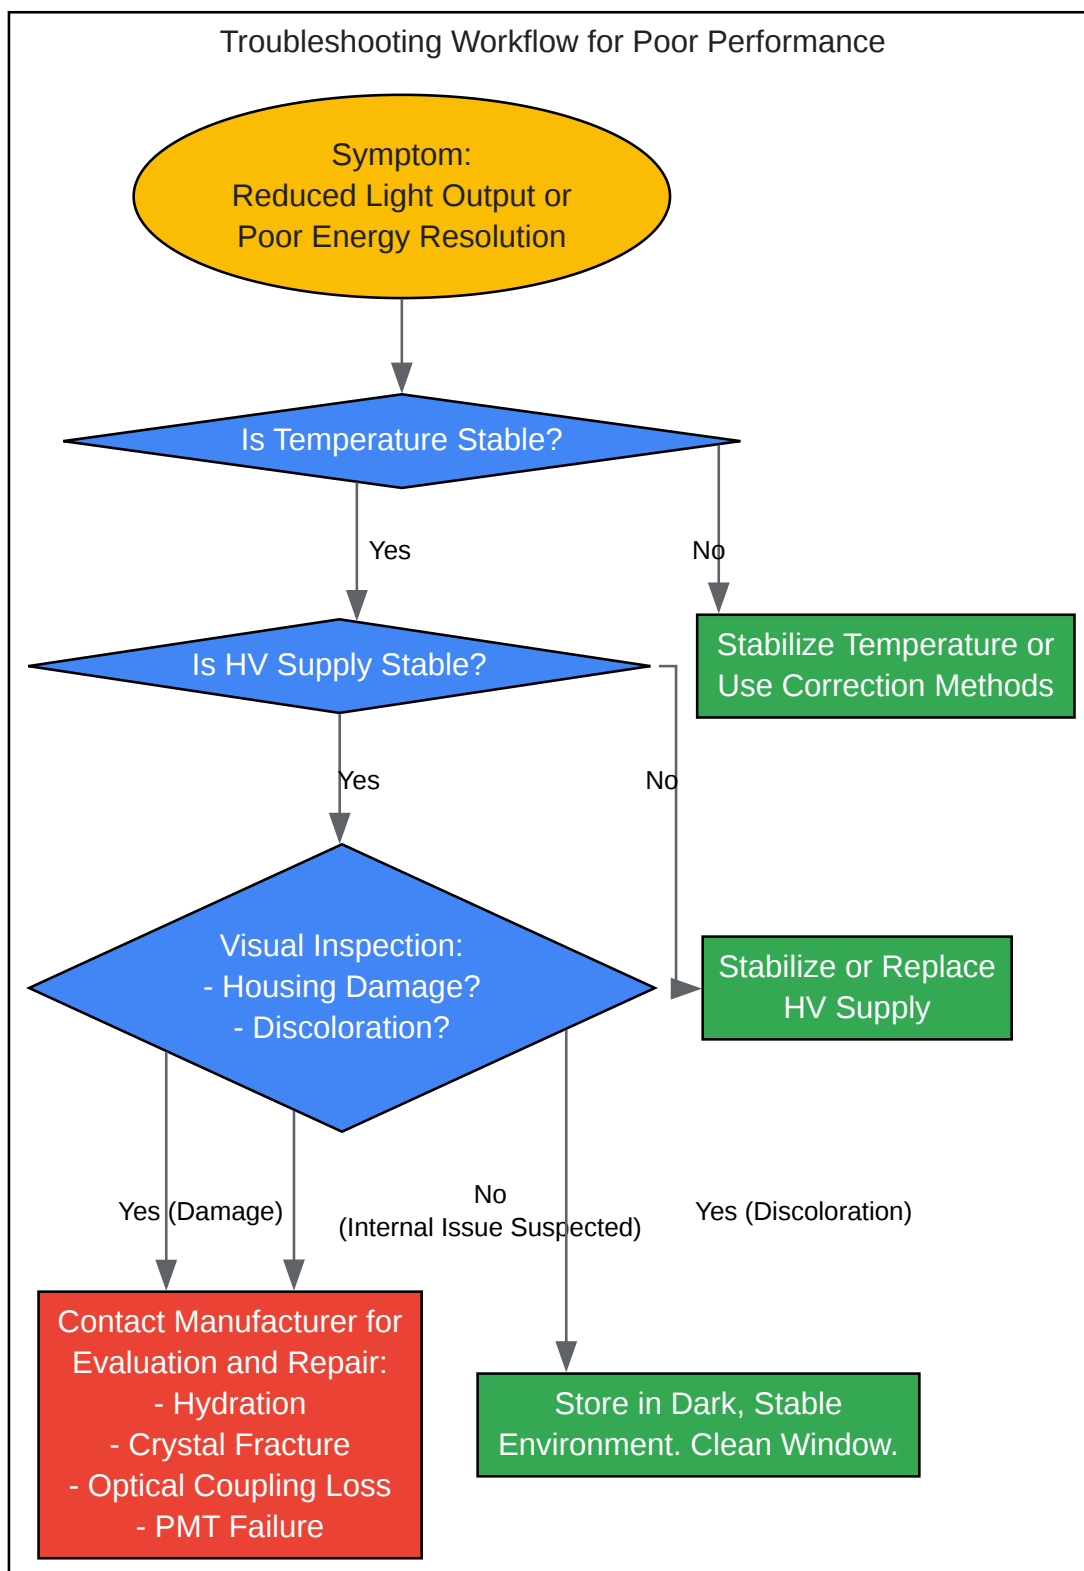
Caption: Troubleshooting workflow for poor NaI(Tl) detector performance.

Possible Cause	Troubleshooting Steps	Corrective Action
Crystal Hydration	Inspect the detector housing for any signs of damage or compromise to the hermetic seal. NaI(Tl) is highly hygroscopic.	If hydration is suspected, the detector will need to be repaired or replaced by the manufacturer. Even a small amount of hydration can significantly impair performance, especially at low energies. [2]
Loss of Optical Coupling	This can be difficult to diagnose without disassembling the detector. A sudden, significant drop in light output can be an indicator.	Contact the manufacturer for evaluation and repair. Some manufacturers offer a no-cost evaluation service. [3]
Crystal Fracturing	A physical shock or rapid temperature change can cause the crystal to fracture. This may not be externally visible.	A fractured crystal will require replacement. Contact the manufacturer for support. [3]
Photomultiplier Tube (PMT) Malfunction	If possible, test the PMT independently of the crystal. Check for stable high voltage supply and signal output.	A faulty PMT will need to be replaced. [3]

Possible Cause	Troubleshooting Steps	Corrective Action
Temperature Fluctuations	Monitor the ambient temperature of the laboratory. The light output of NaI(Tl) scintillators is temperature-dependent.[4][5][6][7]	Maintain a stable laboratory temperature. If temperature fluctuations are unavoidable, use temperature compensation methods, which may involve software corrections or hardware-based gain stabilization.[6][7]
Unstable High Voltage Supply	Monitor the high voltage supplied to the PMT for any fluctuations.	Ensure the high voltage power supply is stable and functioning correctly.
Electronic Noise	Check for sources of electromagnetic interference near the detector and associated electronics.	Ensure proper grounding and shielding of the detector and electronics.
High Counting Rates	Very high counting rates can lead to pulse pile-up and baseline shifts, affecting the measured pulse height.	Reduce the source activity or increase the source-to-detector distance. Use appropriate pulse shaping and pile-up rejection electronics.

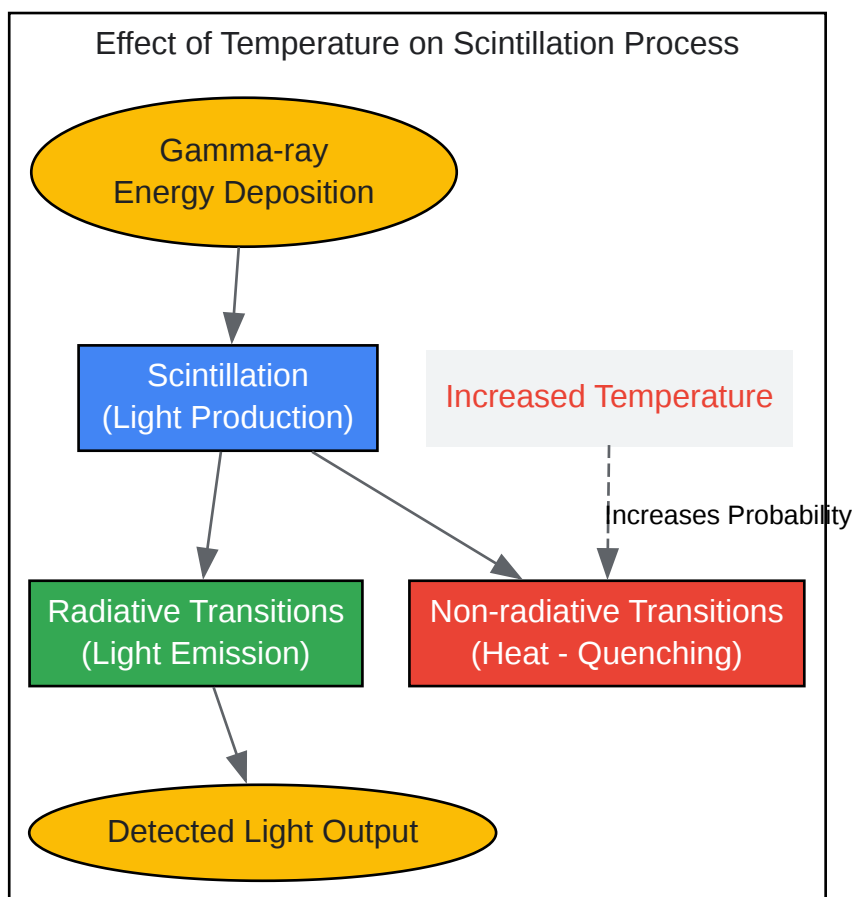
Caption: Temperature's influence on NaI(Tl) scintillation light output.

A2: The light output of a NaI(Tl) scintillator is highly dependent on temperature. In most cases, as the temperature increases, the light output decreases (is quenched).[4] Some studies show a linear dependence of light output over a wide temperature range.[7][10] At temperatures below room temperature, a second, slower decay component can appear in the light pulse, which may affect pulse shape analysis.[7][10] Both the scintillator crystal and the photomultiplier tube (PMT) have temperature-dependent responses.[5] This can cause shifts in the energy spectrum and a deterioration of the energy resolution if the temperature is not stable.[11]
