Troubleshooting 2,4',6-Trichlorobiphenyl peak tailing in GC analysis

Technical Support Center: Gas Chromatography Analysis

Troubleshooting Guide: 2,4',6-Trichlorobiphenyl Peak Tailing

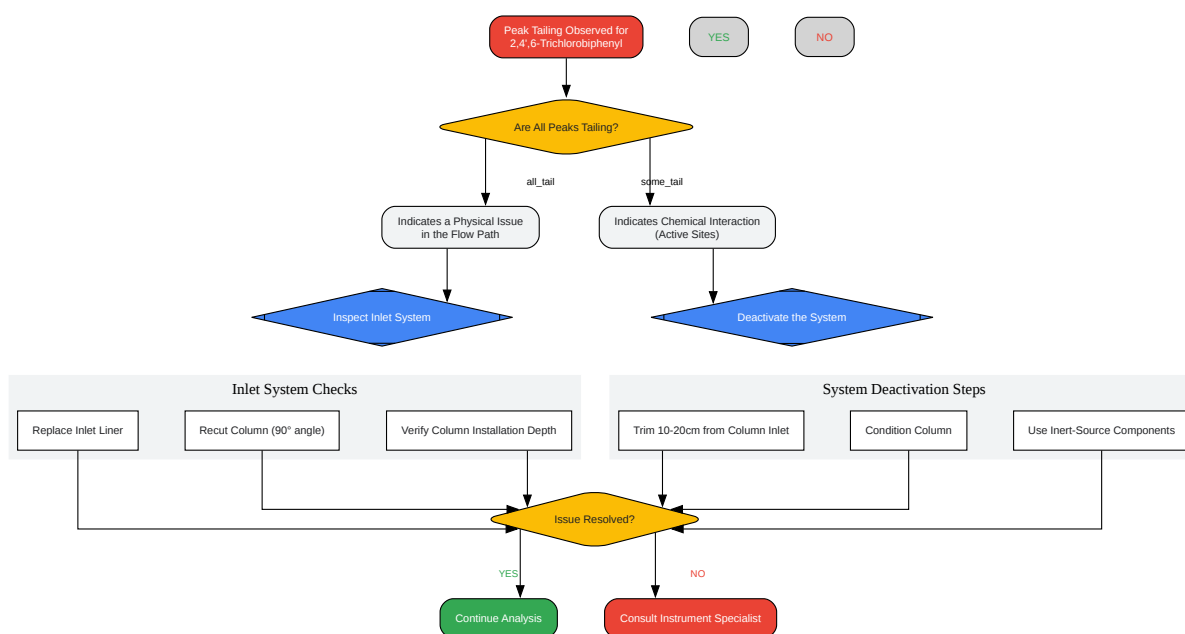
The following diagrams illustrate the logical steps for troubleshooting peak tailing.

Caption: A workflow for troubleshooting peak tailing in GC analysis.

A logical first step in troubleshooting is to determine if the issue is widespread or specific to certain analytes.

- If all peaks in the chromatogram, including the solvent peak, are tailing, the problem is likely related to a physical issue in the GC system.^{[2][3]} This could include disruptions in the flow path, such as a poor column cut or improper installation.^{[1][2][4]}

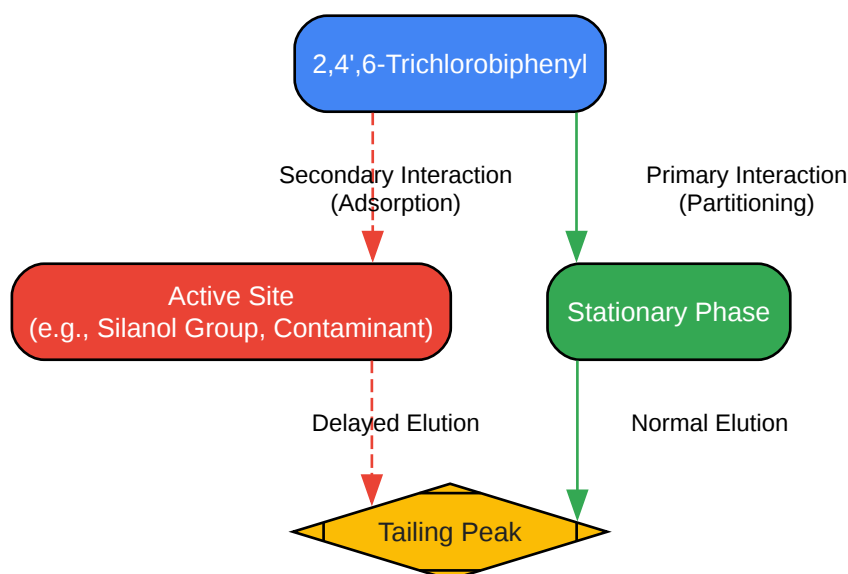
Caption: Interaction pathways leading to peak tailing.

A1: The most common causes of peak tailing for chlorinated compounds like **2,4',6-Trichlorobiphenyl** are typically related to active sites within the GC system. These active sites can interact with the analyte, causing it to be retained longer and resulting in a tailing peak. Other significant causes include:
