Troubleshooting Isodiazinon Peak Tailing in GC Analysis: A Technical Support Guide

Compound Name: Isodiazinon

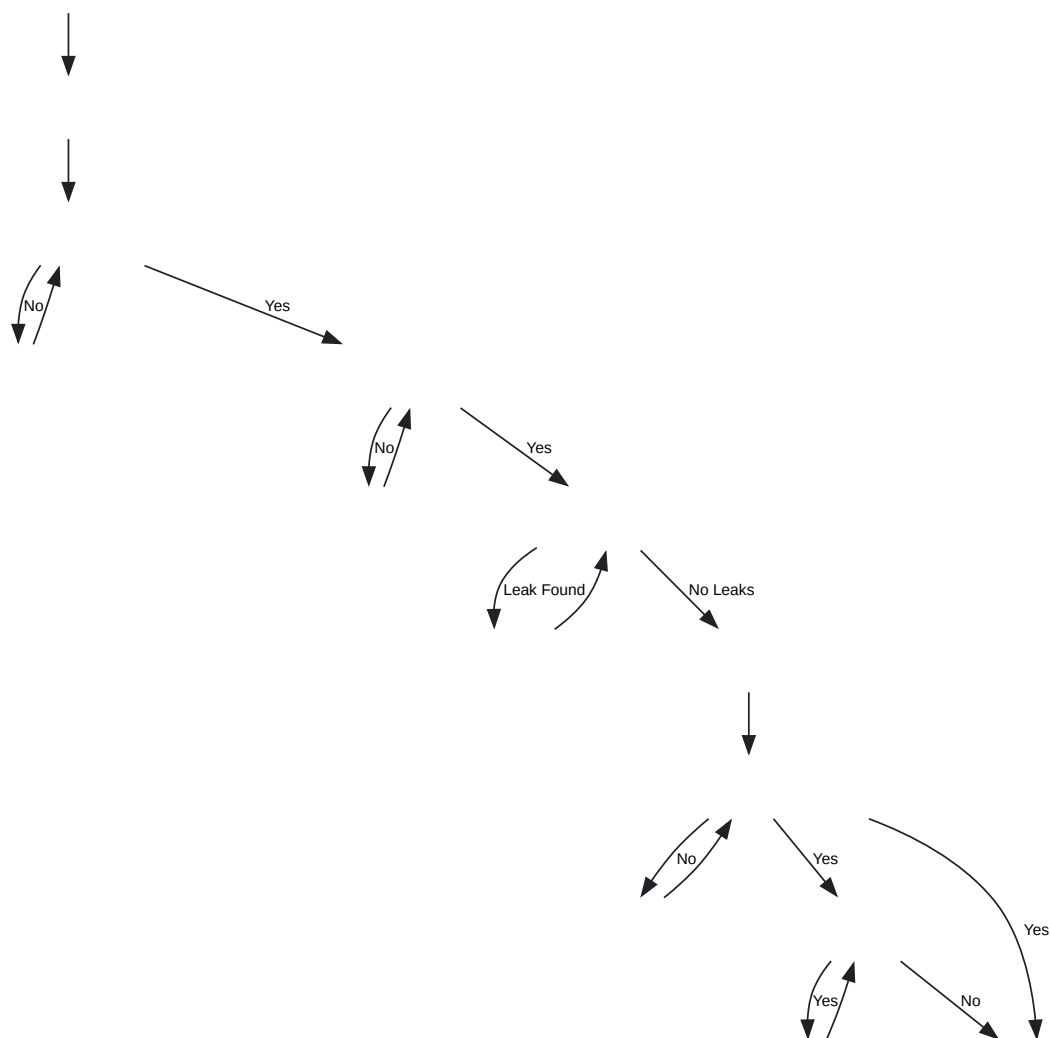
If all peaks in your chromatogram are exhibiting tailing, this generally points to a physical issue within the GC system. Follow this workflow to diagnose and resolve the problem.

Caption: Troubleshooting workflow for universal peak tailing in GC.

- Column Cutting:
 - Use a ceramic scoring wafer or a diamond-tipped scribe to make a clean, square cut across the fused silica capillary column.[\[6\]](#)

- Inspect the cut under a magnifier to ensure it is even and free of shards or jagged edges.
[\[1\]](#) A poor cut can cause turbulence and peak distortion.[\[6\]](#)[\[7\]](#)

- Column Installation:
 - Consult the instrument manufacturer's instructions for the correct column installation depth in both the injector and detector.[\[1\]](#)

- Incorrect positioning can create dead volume, leading to peak broadening and tailing.[\[6\]](#)
- Leak Check:
 - Use an electronic leak detector to check for leaks at all fittings, especially at the inlet and detector connections.

- Leaks can disrupt the carrier gas flow path, causing peak shape issues.[\[5\]](#)
- Inlet Liner Maintenance:
 - Visually inspect the inlet liner for contamination, such as sample residue or septum particles.

- If dirty, replace the liner with a new, deactivated liner.[\[1\]](#) Active sites in a contaminated liner can interact with analytes.[\[8\]](#)

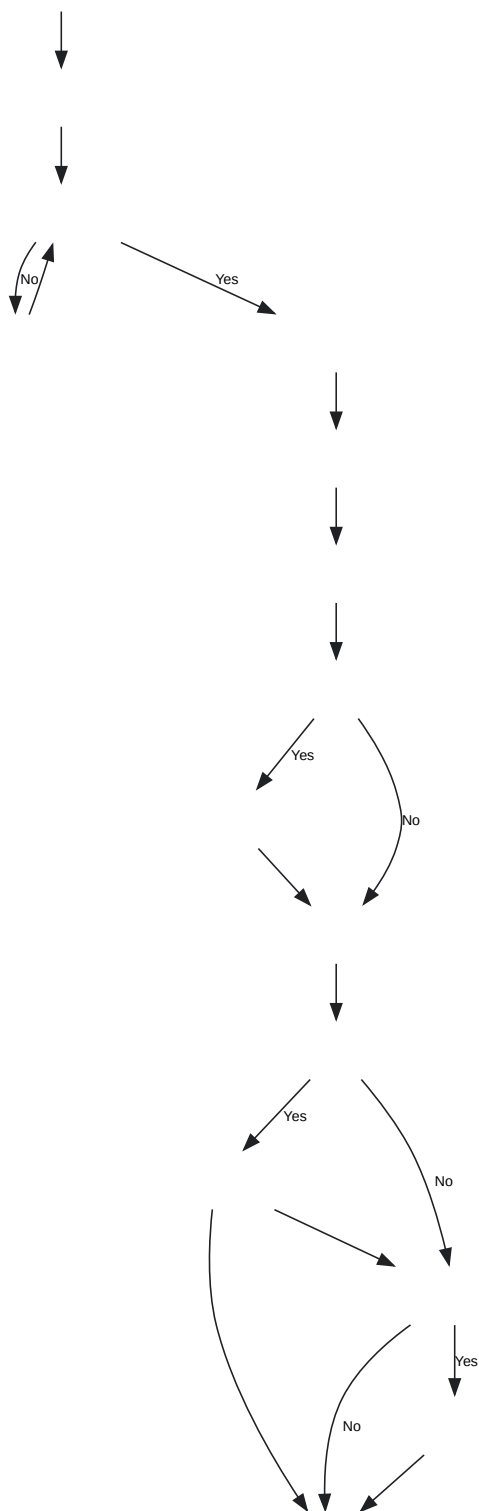
If only the **isodiazinon** peak shows tailing, the cause is likely a specific chemical interaction between the analyte and the GC system.

Caption: Troubleshooting workflow for analyte-specific peak tailing.

- Managing Column Contamination:
 - Column Bake-out: Condition the column by baking it at a temperature close to its upper limit (as specified by the manufacturer) for a few hours to remove less volatile contaminants.[\[9\]](#)

- Optimizing Injection Parameters:
 - Column Overload: Injecting too much sample can saturate the stationary phase and cause peak fronting or tailing.[\[2\]](#) Reduce the injection volume or dilute the sample.[\[11\]](#)

- Solvent Mismatch: The polarity of the injection solvent should be compatible with the stationary phase. A mismatch can cause poor peak shape.[\[12\]](#)
