Technical Support Center: Bright Nickel-Tin Electroplating

Troubleshooting Guide: Pitting

Diagram of the Troubleshooting Workflow for Pitting in Bright Nickel-Tin Electroplating

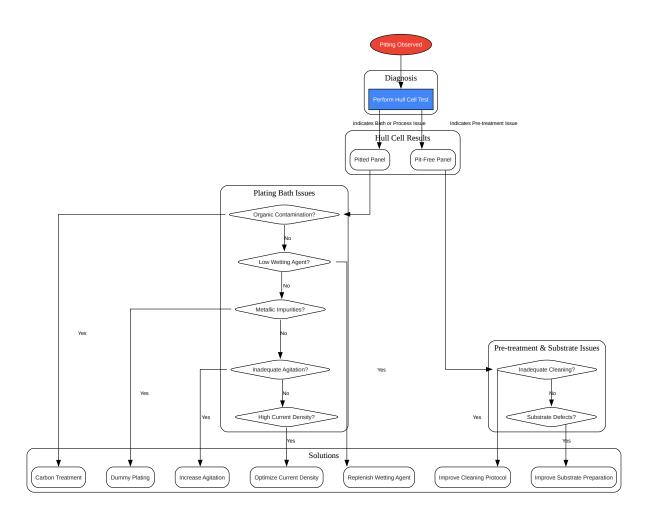
Caption: Troubleshooting workflow for pitting in bright nickel-tin electroplating.

Pitting, the formation of small cavities on the plated surface, is a common defect that can compromise the quality and performance of your nickel-tin coating. This guide will help you diagnose and resolve the root causes of pitting.
