Technical Support Center: MRV-03 Valves - Seal Replacement and Repair

This technical support center provides troubleshooting guidance and frequently asked questions (FAQs) for the seal replacement and repair of MRV-03 series modular relief valves. It is intended for researchers, scientists, and drug development professionals who may encounter issues with these valves during their experiments.

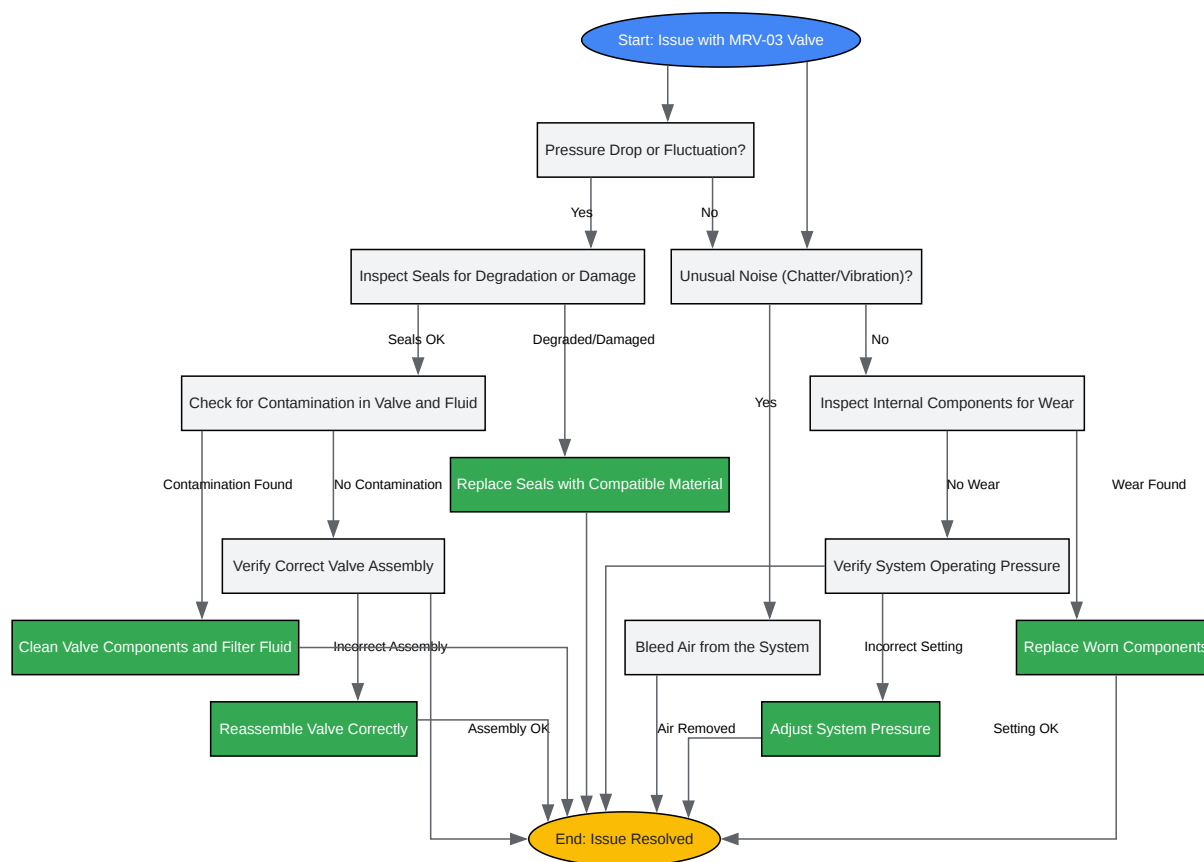
Troubleshooting Flowchart for MRV-03 Valve Issues

Caption: A flowchart outlining the troubleshooting steps for common MRV-03 valve issues.

Q1: My system is experiencing a gradual or sudden pressure drop. What could be the cause?

A1: A pressure drop is often indicative of a leak within the MRV-03 valve, which is typically due to a failed seal. Here are the common causes and troubleshooting steps:

Q2: The valve is making an unusual chattering or vibrating noise. What does this indicate?

A2: Valve chatter or vibration can be caused by several factors:

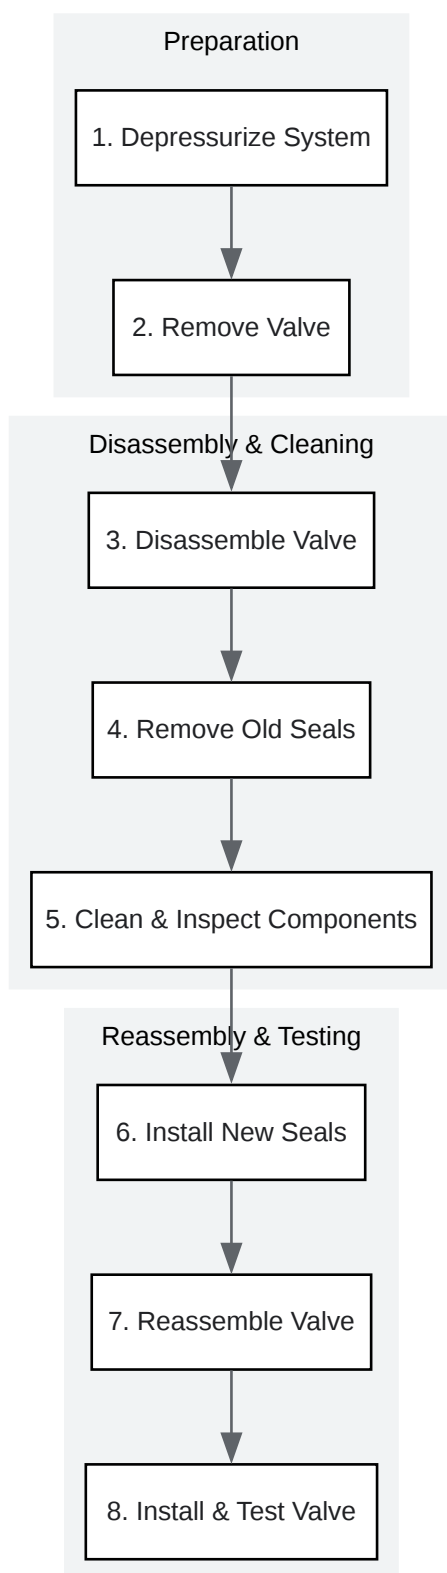
Experimental Workflow for MRV-03 Valve Seal Replacement

Caption: A step-by-step workflow for the replacement of seals in an MRV-03 valve.

Procedure:

- System Depressurization: Ensure the hydraulic system is completely depressurized and locked out before proceeding.
- Valve Removal: Carefully disconnect the fluid lines and remove the MRV-03 valve from its mounting.

- Disassembly:
 - Place the valve on a clean work surface.
 - Using the appropriate hex key, carefully unscrew and remove the adjustment knob or screw.
 - Remove the spring and poppet assembly. Keep all parts organized.

- Seal Removal:
 - Using a non-metallic pick, carefully remove all the old O-rings from their grooves.
 - Take care not to scratch the sealing surfaces.
- Cleaning and Inspection:

- Seal Installation:
 - Lightly lubricate the new O-rings with a compatible lubricant.
 - Carefully install the new O-rings into their respective grooves, ensuring they are not twisted.
- Reassembly:
 - Reassemble the valve components in the reverse order of disassembly.
 - Ensure the spring and poppet are correctly seated.
 - Tighten the adjustment knob or screw. If a torque specification is available, use a torque wrench.
- Installation and Testing:
 - Reinstall the valve in the system.
 - Slowly and carefully repressurize the system and check for any leaks around the valve.
 - Test the valve's function to ensure it is operating at the correct pressure setting.
