# Technical Support Center: Troubleshooting Peak Tailing in Atrazine GC-MS Analysis

**Author:** BenchChem Technical Support Team. **Date:** December 2025

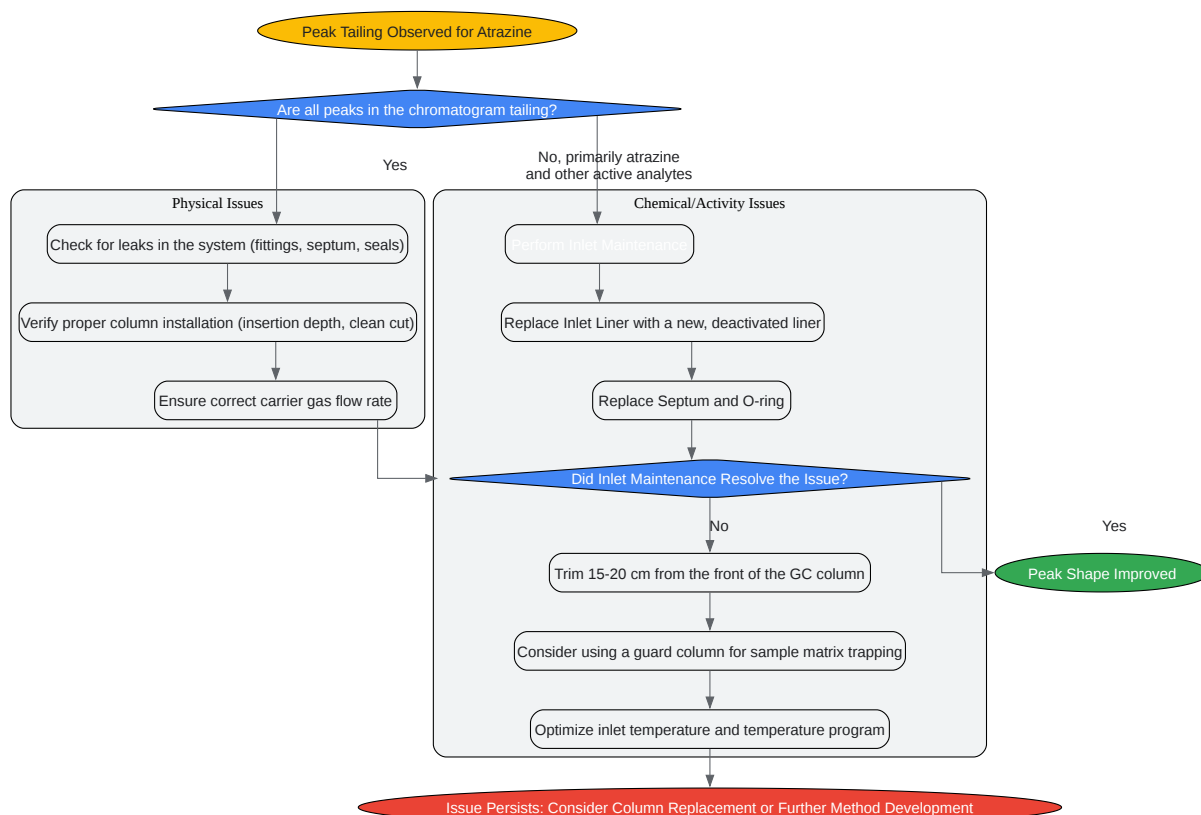
The following diagram illustrates a logical workflow for troubleshooting peak tailing issues in **atrazine** GC-MS analysis.

Caption: Troubleshooting workflow for **atrazine** GC-MS peak tailing.

- Scenario 1: All peaks in the chromatogram are tailing. This generally points to a physical problem in the GC system, such as improper column installation or a leak.
- Scenario 2: Only the **atrazine** peak (and other active compounds) are tailing. This is a strong indicator of chemical interactions with active sites within the system.
